PAVEMENT CONDITION ASSESSMENT OF ASPHALT SURFACED NATIONAL HIGHWAY

Pavement defect assessment, Pavement condition index, Network survey vehicle, Image capturing, National highway

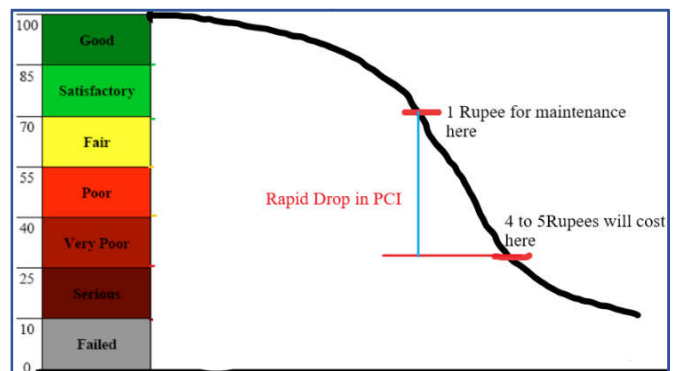
Figure 1 The effect of PCI on type and cost of maintenance works

Pavement Manage System (PMS) is a tool used to monitor the pavement condition after the construction and for timely response to adopt the proper and cost-effective maintenance solutions. It includes a system of designed methods for the data collection and storing it for the future action plans. An awareness of pavement conditions is necessary to programmed short, medium and long-term maintenance works within a systematic management system. PMS can handle the pavements at both project and network levels. At network level, PMS provides a basis for decision-making in-view of the long-term budgeting plans. It provides only the required information and support for decision making but, it doesn't make decisions. The PMS mainly composed of a) PCI-assessment, b) Evaluation of cost-effective solutions, c) Data Acquisition System and d) Data-Base Management. With this background, the present study aimed to focus on one of the components i.e., the evaluation of PCI. The evaluation of PCI is an important parameter helps in determining the type of maintenance works required at that particular time and particular location. (Figure 1)

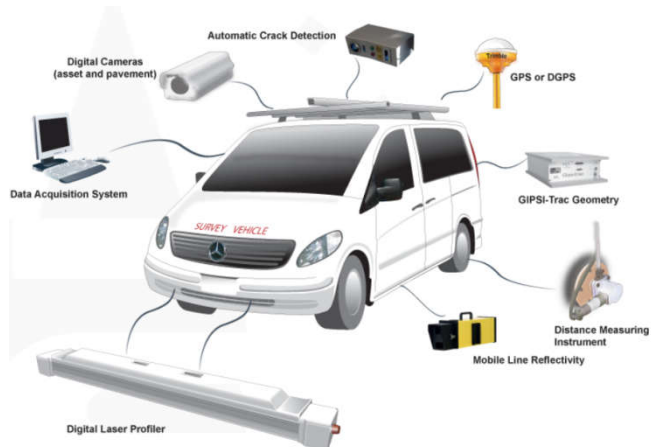
Figure 2 The Hawkeye 2000 Network Survey Vehicle

In this study, Indian Road Survey and Management (IRSM) based Hawkeye 2000-Network Survey Vehicle (NSV) was utilized for capturing the asphalt pavement surfaces. Detecting, classifying and quantifying the pavement defects. The adopted NSV attached with Digital Cameras, Data Acquisition System, GPS/DGPS, GIPSI-Trac Geometry, Distance Measuring Instrument (DMI) and Digital Laser Profiler (DLP) as shown in figure 2. The attached DLP arranged with 11 lasers to cover a 3m road width and used for evaluating not only the rutting but also the macro texture of the asphalt surfaces. The in-built software for processing the digital images was considered for

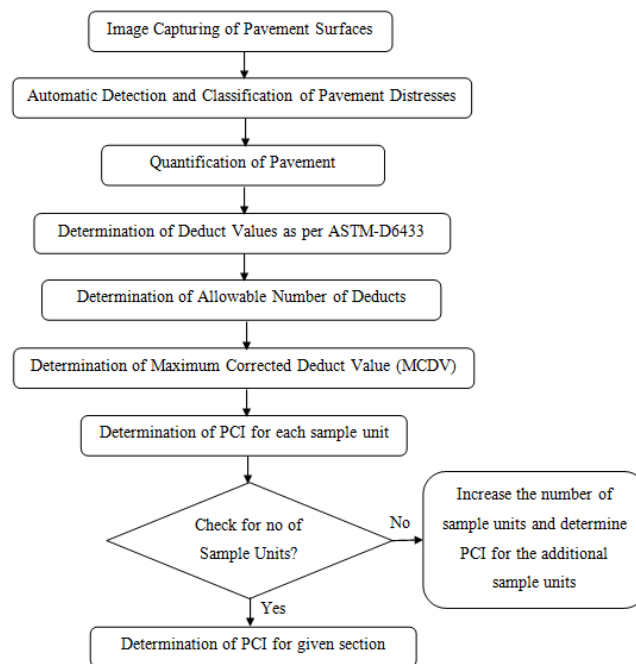
Figure 3 The study methodology for determination of PCI for given section

The methodology of current study consists of a set of sequential stages in order to determine the condition of selected pavement sections (figure 3). Firstly, the pavement images were captured by the aforementioned NSV for every 10m stretch. The each and every stretch was taken as one sample units. In this study, a total of 200 sample units were considered for 2km road-section. Secondly, the images were digitized and the pavement defects were detected, classified and quantified using the in-built software. Thirdly, the density of corresponding pavement distresses was determined. Later, the deduct values were determined for obtained densities and corresponding severity levels (as per ASTM-D6433). After determination of deduct values, the allowable number of deductions (AND) and maximum corrected deduct values (MCDV) were computed. Finally, the pavement condition index (PCI) for a given 10m stretch of highway was evaluated by subtracting the MCDV from 100%.

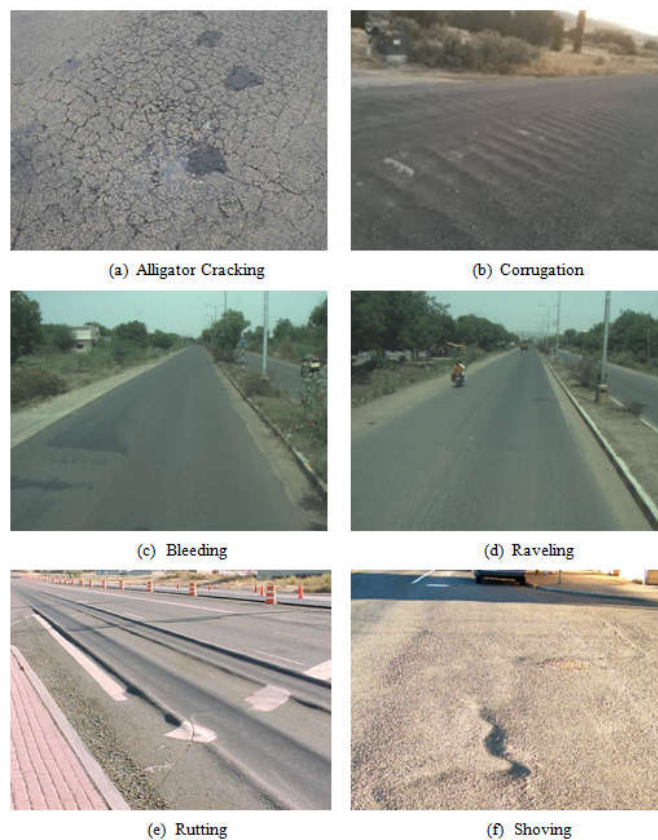
The present study involved in evaluating the pavement distresses which were captured by the three front cameras mounted on NSV. The sample images of selected pavement surface are shown in following figure 4.

Figure 4 The different distresses of National Highway-752
